ESL-TR-79-18

DEVELOPMENT OF A PAVEMENT MAINTENANCE MANAGEMENT SYSTEM VOLUME VI: M&R GUIDELINES -- VALIDATION AND FIELD APPLICATIONS

MOHAMED Y. SHAHIN
CONSTRUCTION ENGINEERING RESEARCH LABORATORY
CHAMPAIGN, ILLINOIS 61820

DECEMBER 1979
INTERIM REPORT
SEPTEMBER 1977 - JULY 1979

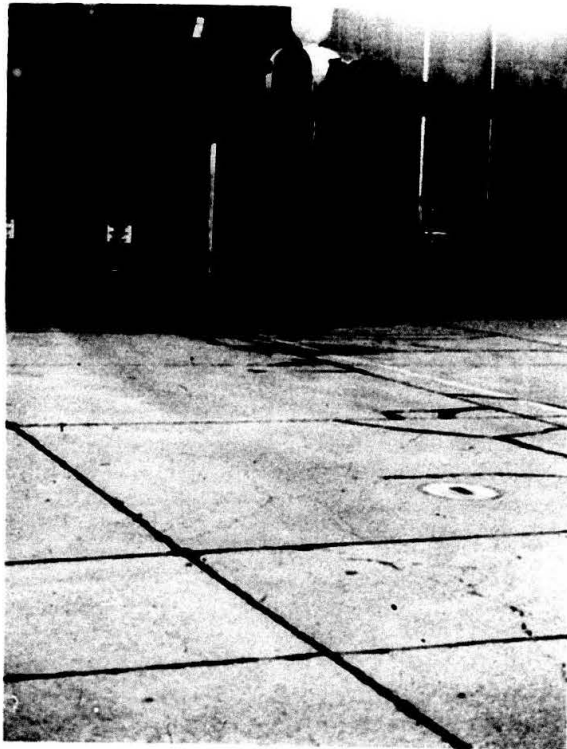
Figure 40. Pavement Damage Along Traffic Lines.

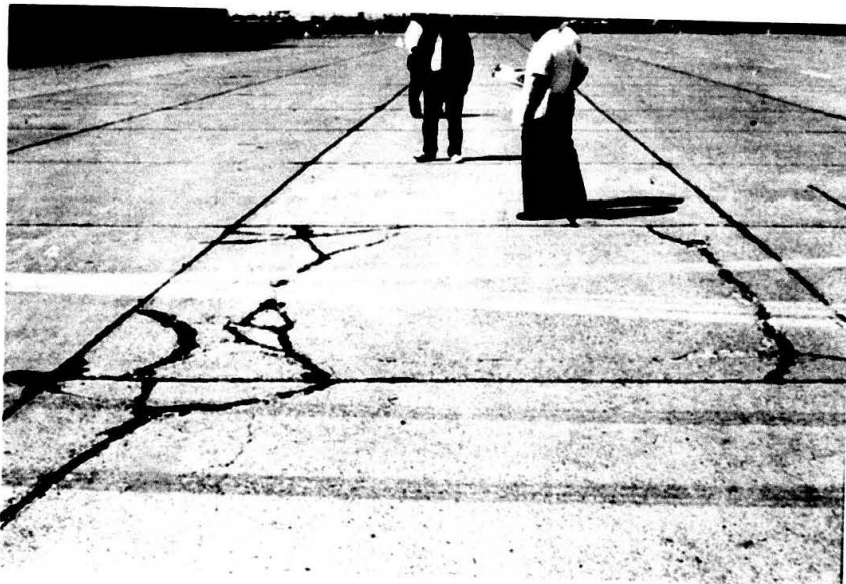
Figure 41. Severely Shattered Slab Located Along Traffic Line.

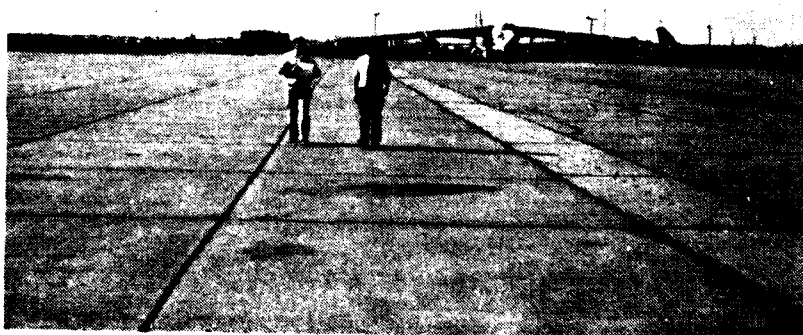
Figure 42. General View of Slabs in Apron.

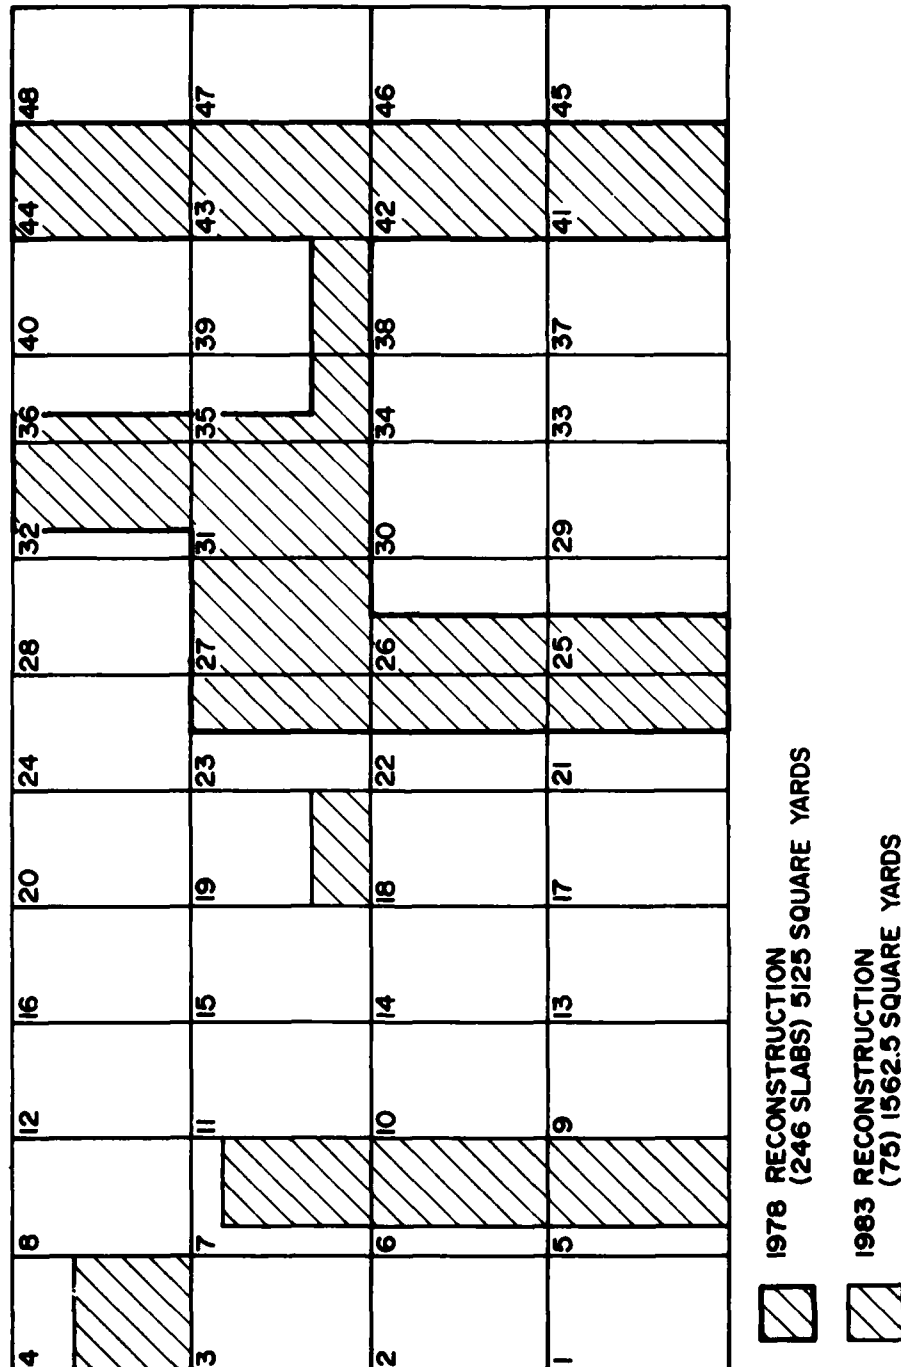
Alternatives 2 and 3 are by far the most economical, and alternative 2 also has the advantage of a lower initial cost (1978 cost). Adoption of alternative 3 (bonded overlay) will also require special adjustments in the levels of the floors of the B-52 maintenance hangers. On the other hand, by only structurally improving the current traffic area (alternative 2) caution should be taken to insure that aircraft movements are limited to the markings on the pavement.

Figure 47. Alternative 2 -- Reconstruct the Shaded Area and Perform Localized Repair as Needed on Other Portion.
